# DDASaccident208

# DDAS Accident Report

REPORT OF BOARD OF INQUIRY INTO ACCIDENT 08 APRIL 1999

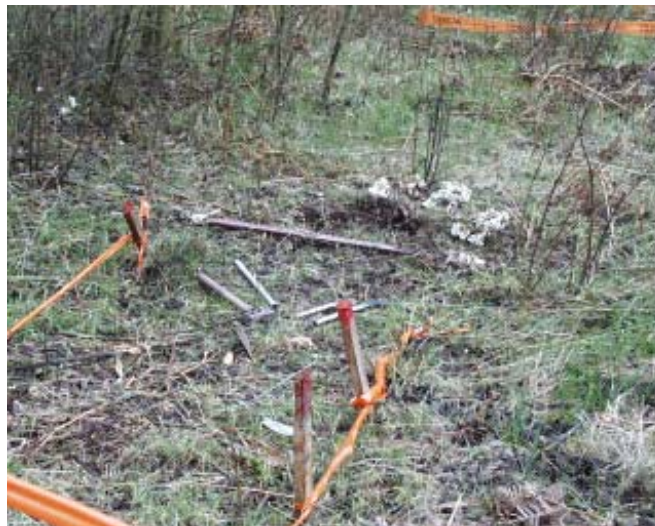
The accident occurred in an open corner of the site with a dirt road 100 metres to the North and a line of trees and bushes "directly adjacent". The weather was cloudy but dry and the temperature about 15°C. The victim was using a Schiebel AN 19/2 detector.

[The photograph shows the accident site.]
